# Qualitative description of estuarine impacts in relation to sedimentation at three estuaries along the Abel Tasman coast

Research, survey and monitoring report number 882

*A report prepared for:  
Sustainable Marahau Incorporated  
198 Marahau Valley Road  
Marahau, 7175*

April 2018

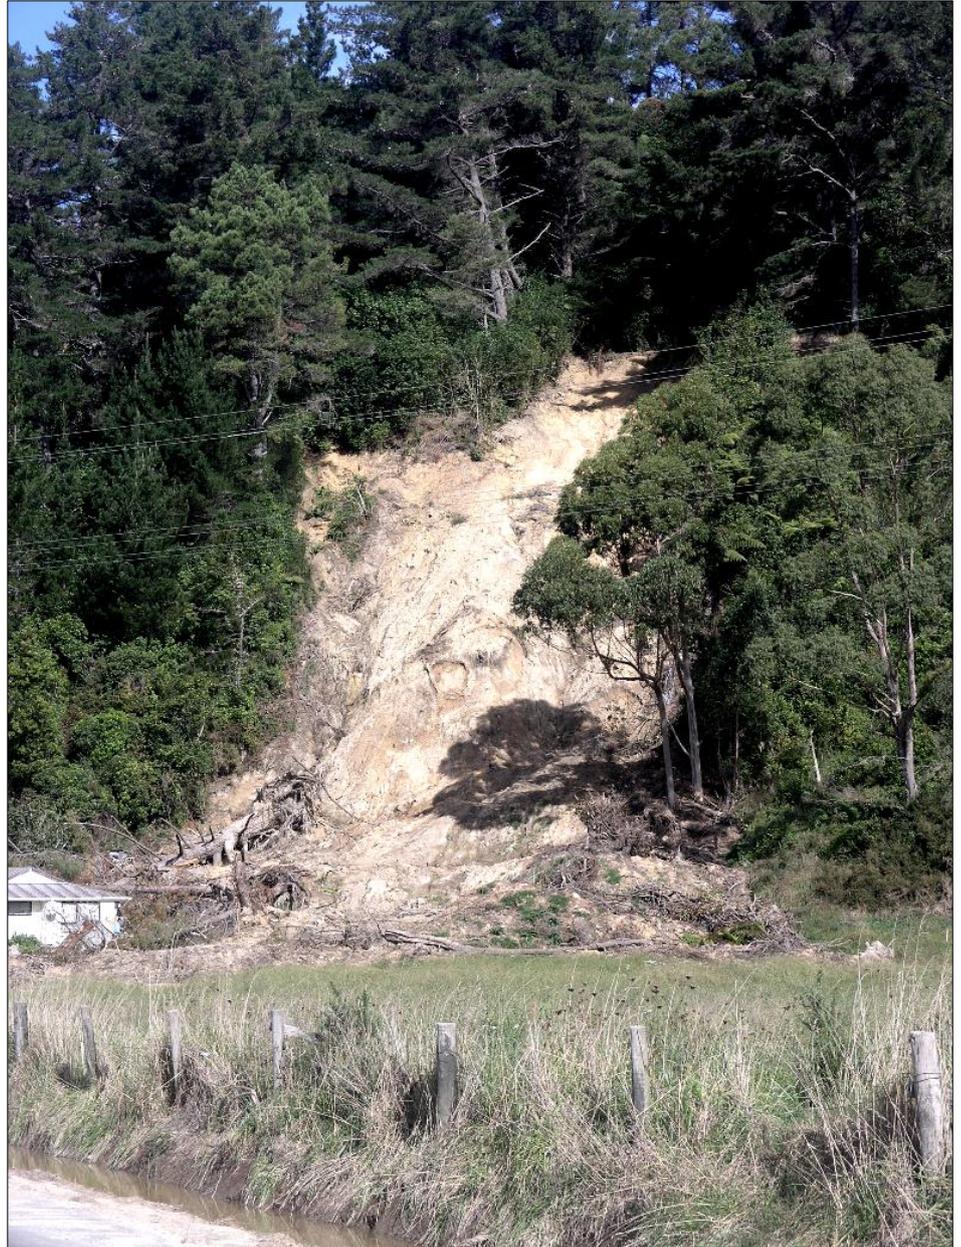
**Plate 1. One of many slips along the hillsides next to Otuwhero Estuary.**

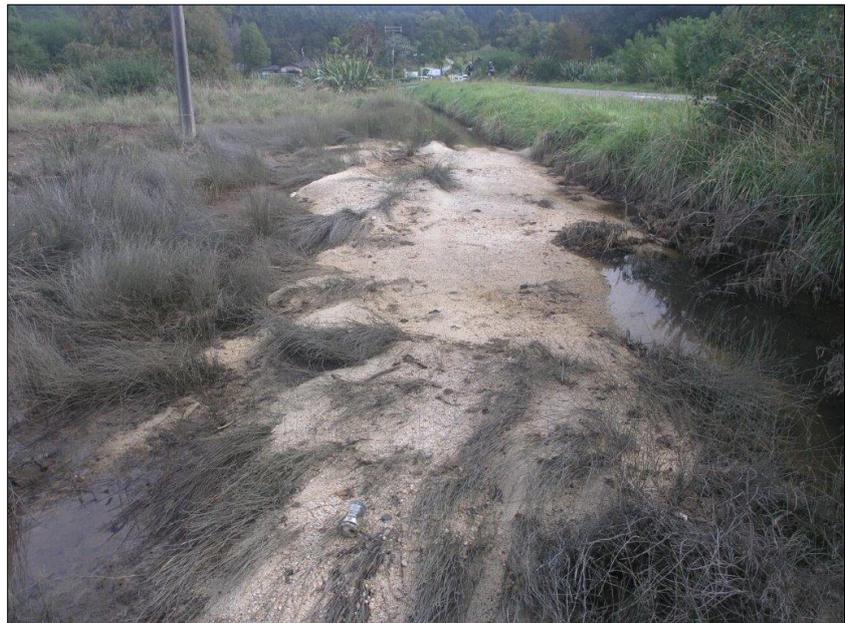
A total of 27 photographs were collected from Kaiteriteri Estuary. Of those, 17 were established as photo points that can be used for future visual comparisons. Overall, the Estuary appears little impacted by the recent Cyclone Gita event. Coarse substrata are widespread in the small streams and was actively travelling downstream during field work (Plate 11).

**Plate 11. New coarse sediment deposited at the foot of a small stream as it enters Kaiteriteri Estuary (photo 9).**

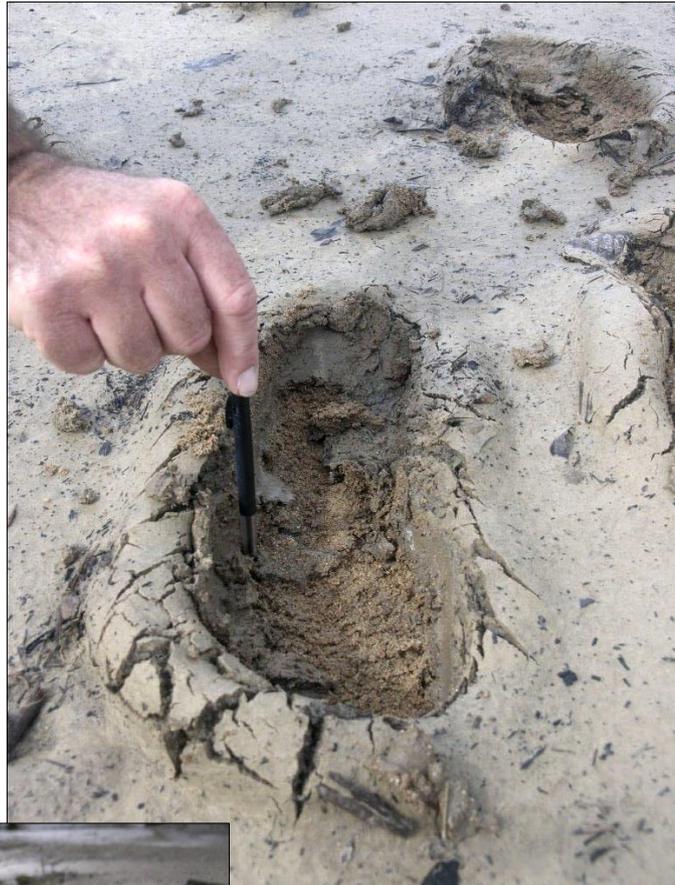
At locations along the edges of the stream as it flowed through the estuary delta, silt and clay material were observed as a layer on top of coarse base sediments (Plate 12). This fine material was new, as few crab burrows were observed on this fine sediment layer. Core samples confirmed the base layer was composed of coarse sand material with no other layers or fine sediment down to 15 cm depth (Plate 13).

**Plate 12. New fine sediment deposited over the top of coarse base sediment adjacent to the main stream near mean high water mark in Kaiteriteri Estuary (photo 18).**

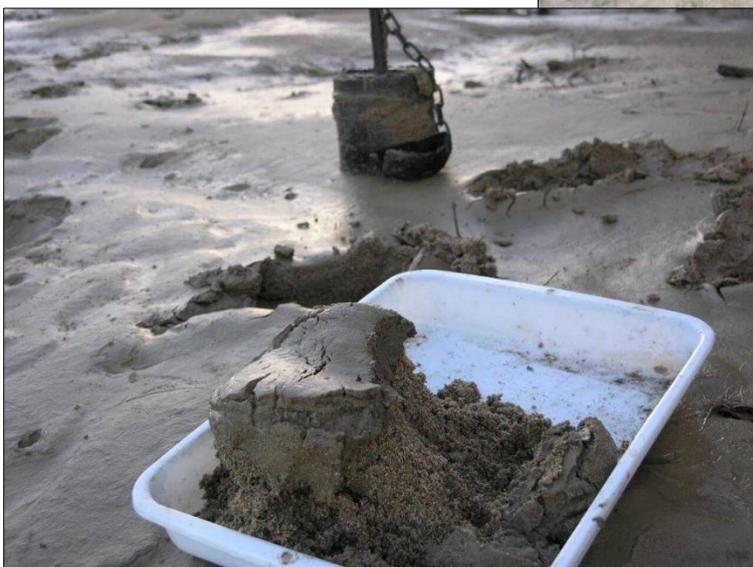
**Plate 13. New fine sediment deposited over the top of coarse base sediment adjacent to the main stream near mean high water mark in Kaiteriteri Estuary (photo 55).**

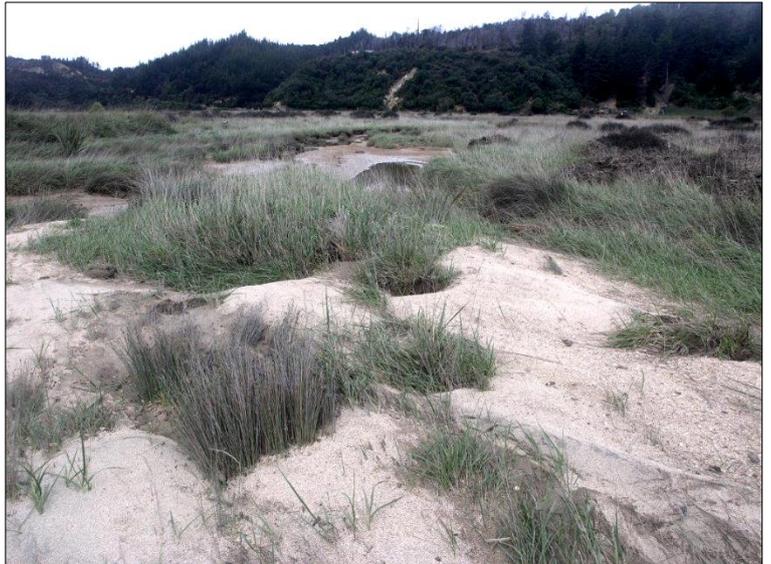
A total of 24 photographs were collected from Otuwhero Estuary. Of those, 17 were established as photo points that can be used for future visual comparisons. Overall, the Estuary has been impacted by the recent Cyclone Gita event. Coarse and highly mobile substrata was widespread and up to 1 metre deep in the main river. This coarse material was observed actively travelling downstream during field work. Coarse substrata had also been deposited into the upper estuarine delta (Plate 14).

**Plate 14. Coarse sediment deposited into the upper estuarine areas of Otuwhero Inlet (photo 33).**

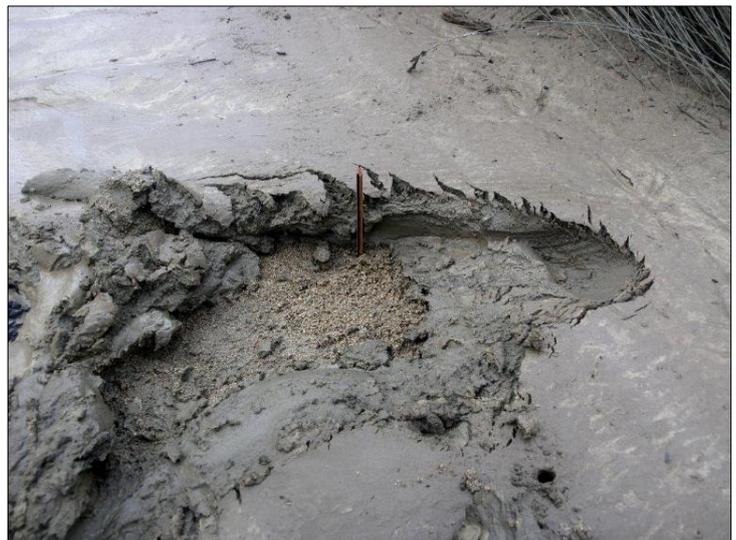
Along the stream edges, silt and clay had been deposited onto original estuarine coarse sediments (Plate 15). Collection of a core sample confirmed mud substrata was restricted to the surface layer over a base of coarse sand (Plate 16).

**Plate 15. New fine sediment deposited over the top of coarse base sediment adjacent to the main stream near mean high water mark in Otuwhero Inlet (photo 37).**

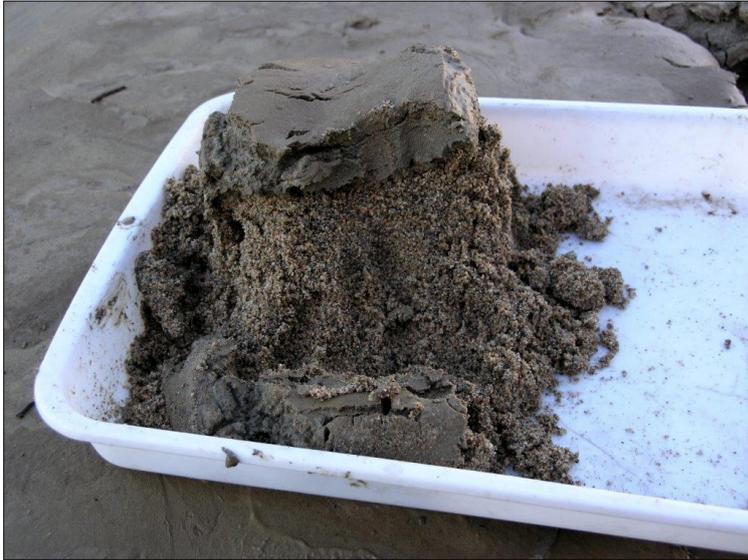
**Plate 16. New fine sediment deposited over the top of coarse base sediment adjacent to the main stream near mean high water mark in Otuwhero Inlet (photo 52).**

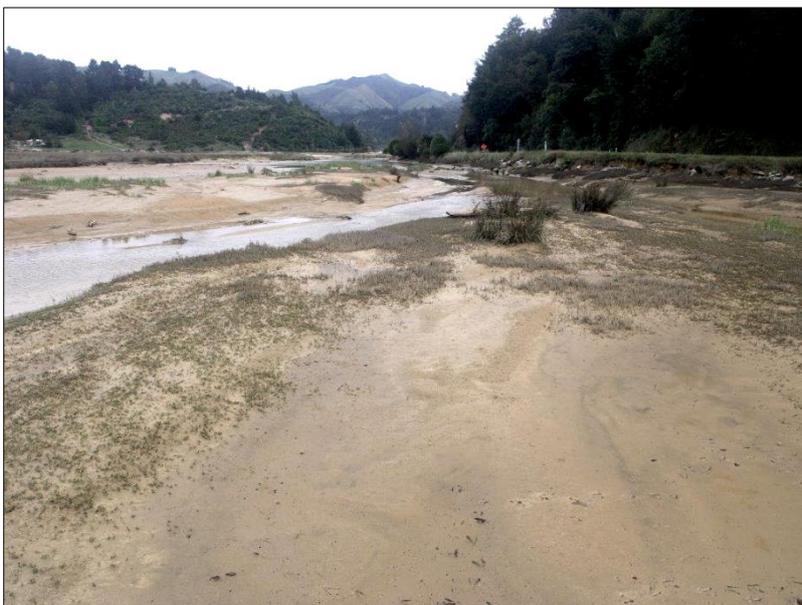
Further away from the stream, mud had also been deposited into and onto herb field communities. These plants had been partially or completely smothered (Plate 17).

**Plate 17. New fine sediment deposited over and through herb-field communities adjacent to the main stream near mean high water mark in Otuwhero Inlet (photo 52).**

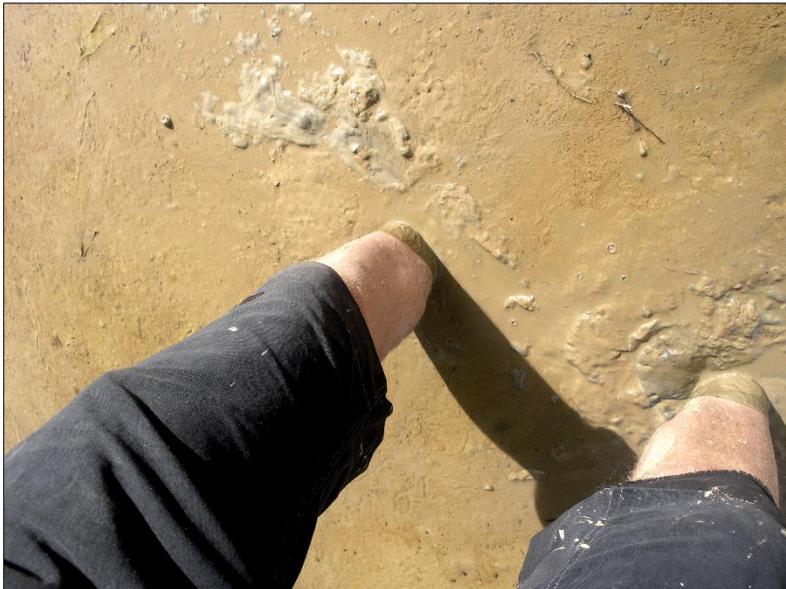
On the inside of the Otuwhero Spit, an area of very fine and water-logged mud was observed (Plates 18 and 19). This area was previously characterised by mud; however, a new layer of very fine light brown mud had been recently deposited (Plate 18 and 19).

**Plate 18. Extremely fine and waterlogged soupy sediment inside the Otuwhero Spit.**

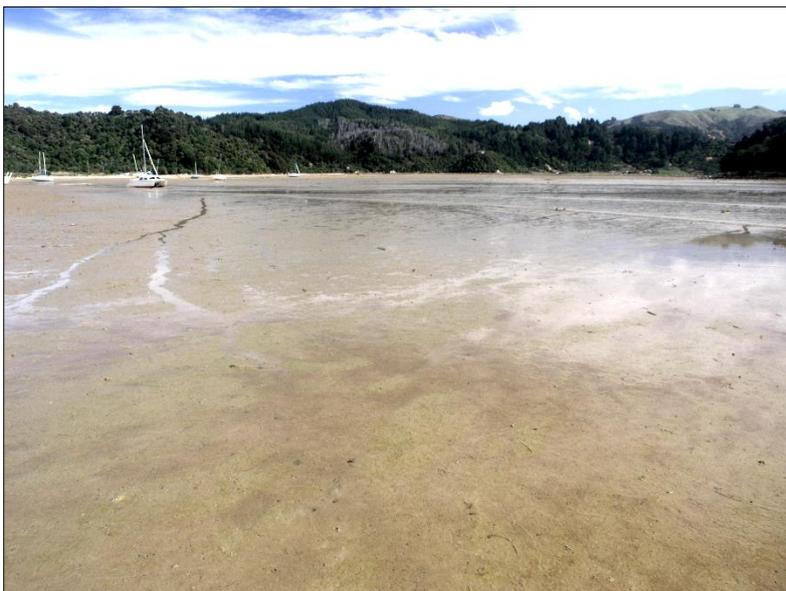
**Plate 19. Area of fine and waterlogged sediment inside the Otuwhero Spit.**

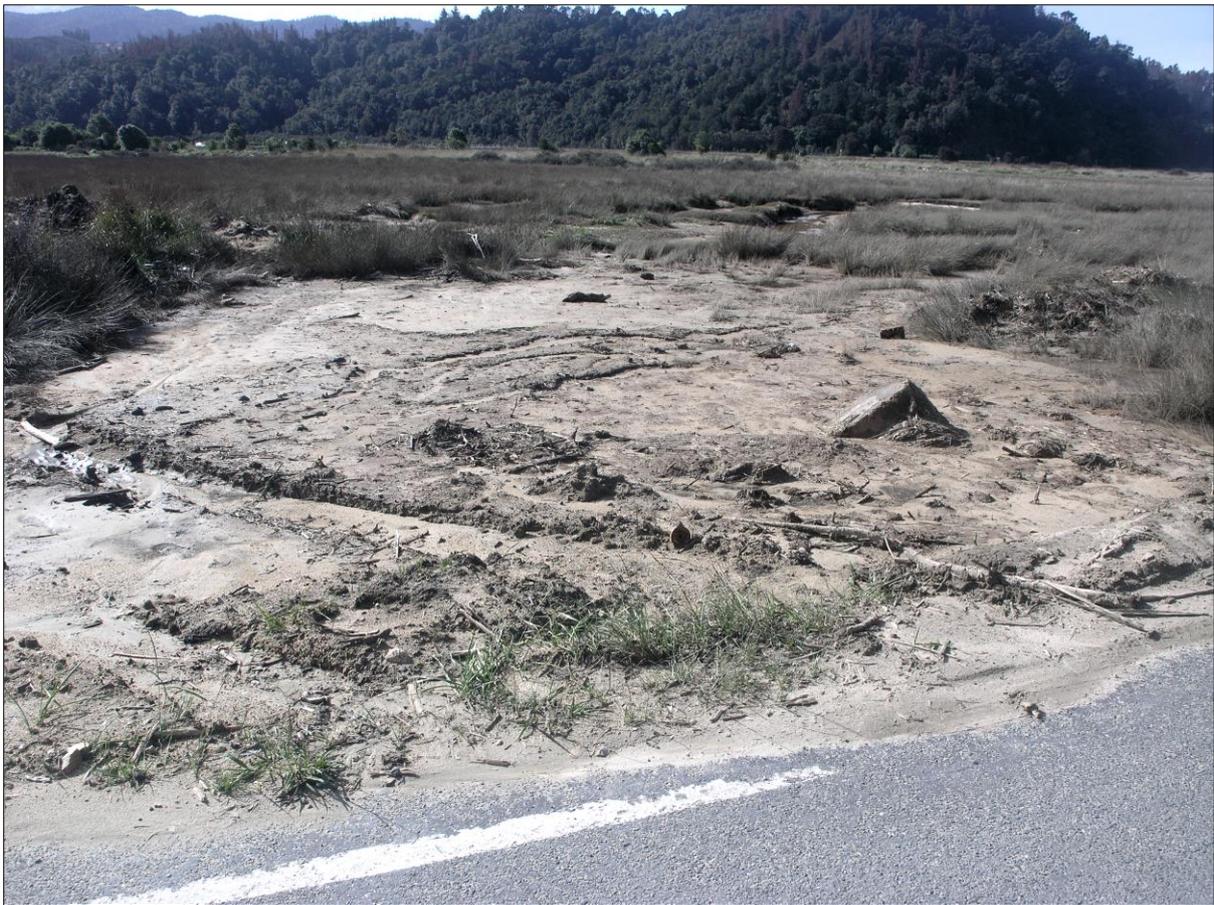
Around the margins of Otuwhero Inlet, adjacent land slips had deposited sediment into upper tidal areas completely smothering salt marsh habitat at several locations (Plate 20). Where this has raised the estuary above the maximum tidal limit for salt marsh and herb field species, exotic grasses will now grow. This represents a permanent loss of salt marsh habitat.

**Plate 20. Smothered salt marsh around the upper edges of Otuwhero Inlet along the Marahau to Kaiteriteri Road.**

To reduce further estuary degradation, carefully crafted integrated catchment management is required. Such a management Plan also requires “buy-in” from the catchment land owners. In particular, the Otuwhero catchment is large and will always carry significant sediment during large rainfall events, however, there are a number of activities exacerbating the

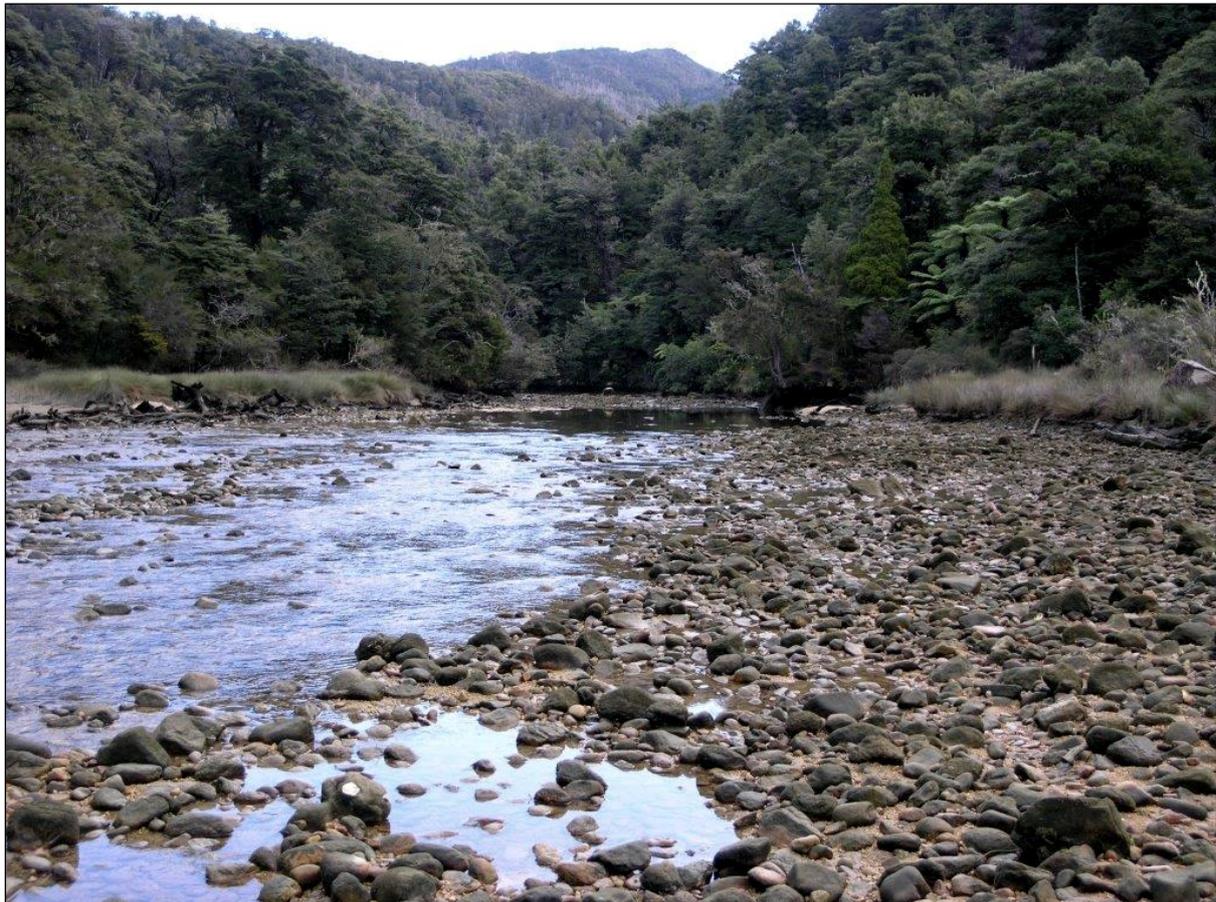
**Plate 21. Torrent River as it enters the head of Torrent Bay Estuary (photo 49).**

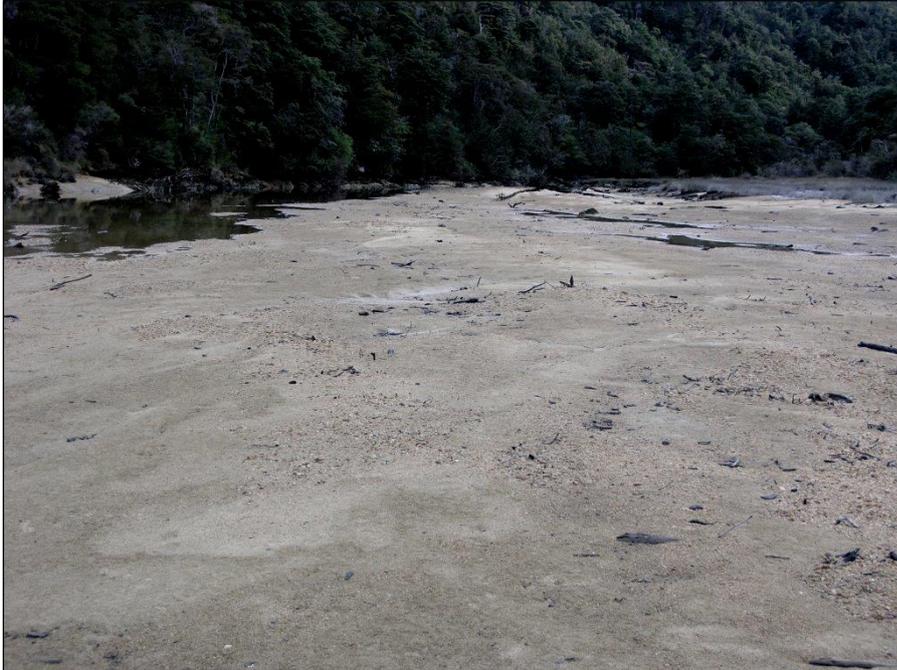
A total of 10 photographs were collected from Torrent Bay Estuary. Of those, 9 were established as photo points that can be used for future visual comparisons. Overall, the Estuary appears unaffected by the recent Cyclone Gita event. The river bed at the head of the estuary was dominated by cobbles and boulders with some coarse sands (Plate 21). The estuary was characterised by coarse substrata with no indication of a silt layer (Plate 22). A core sample collected adjacent to the main river near mean high water showed no fine sediment bands and an absence of a mud surface layer (Plate 23).

**Plate 21. Torrent Bay Estuary characterised by sandy substrata near its head (photo 45).**

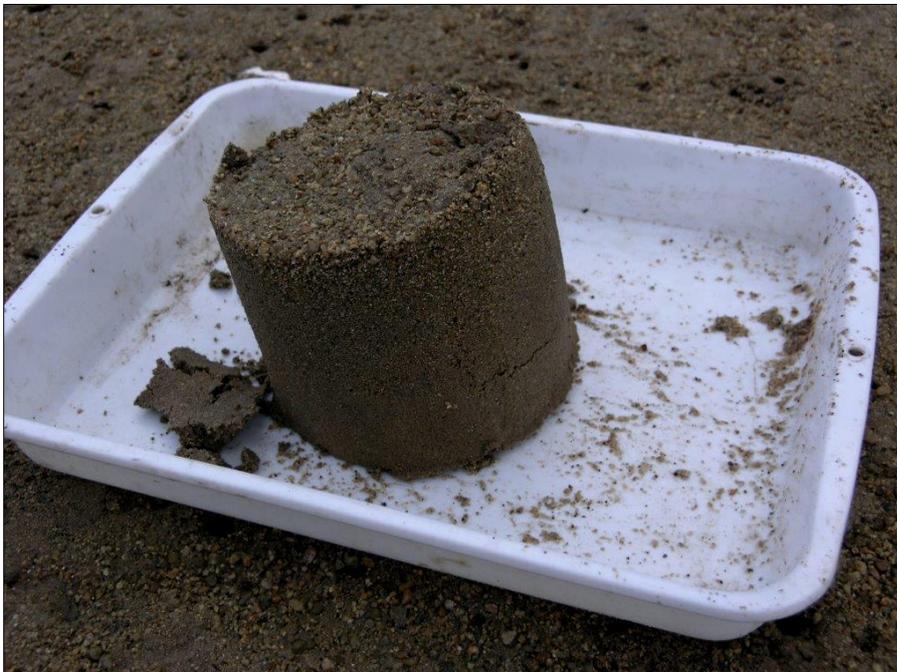
**Plate 22. Core sample near mean high water adjacent to Torrent River channel (photo 50a).**
